SB, Motor heat tolerance update, DM220, DM230, 2015-11

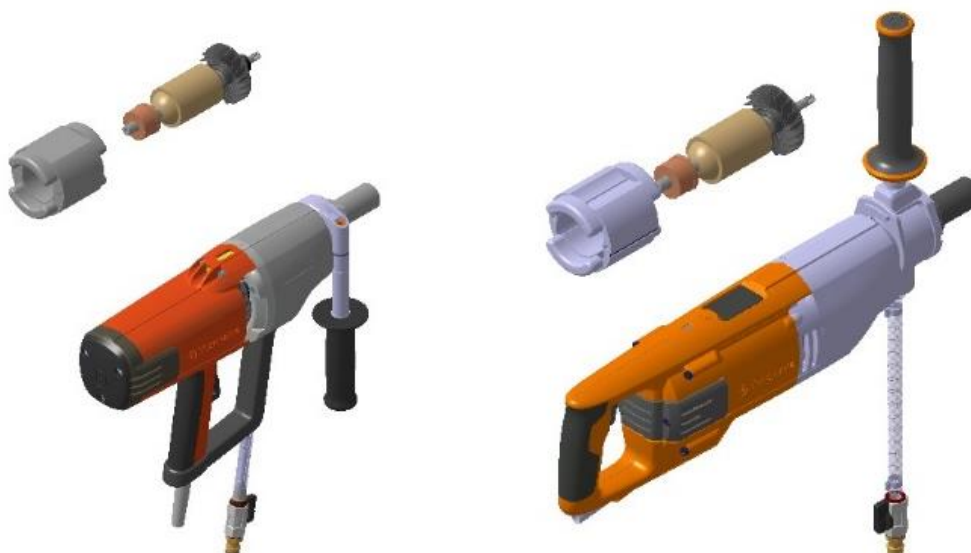
Parts for the DM220 and DM230 have been updated to increase motor heat tolerance. Changes include:

- Updated materials of the insulation material in the Rotor
- The Stator/Rotor gap has increased
- The Stator has received metal clips on the coils instead of the nylon based clips seen today

Figure 1. DM220 and DM230 Rotor and Stator.

Repair and replace damaged parts.
