## SB, Flap update, S-Line, T4000 & C-3000, 2021-12

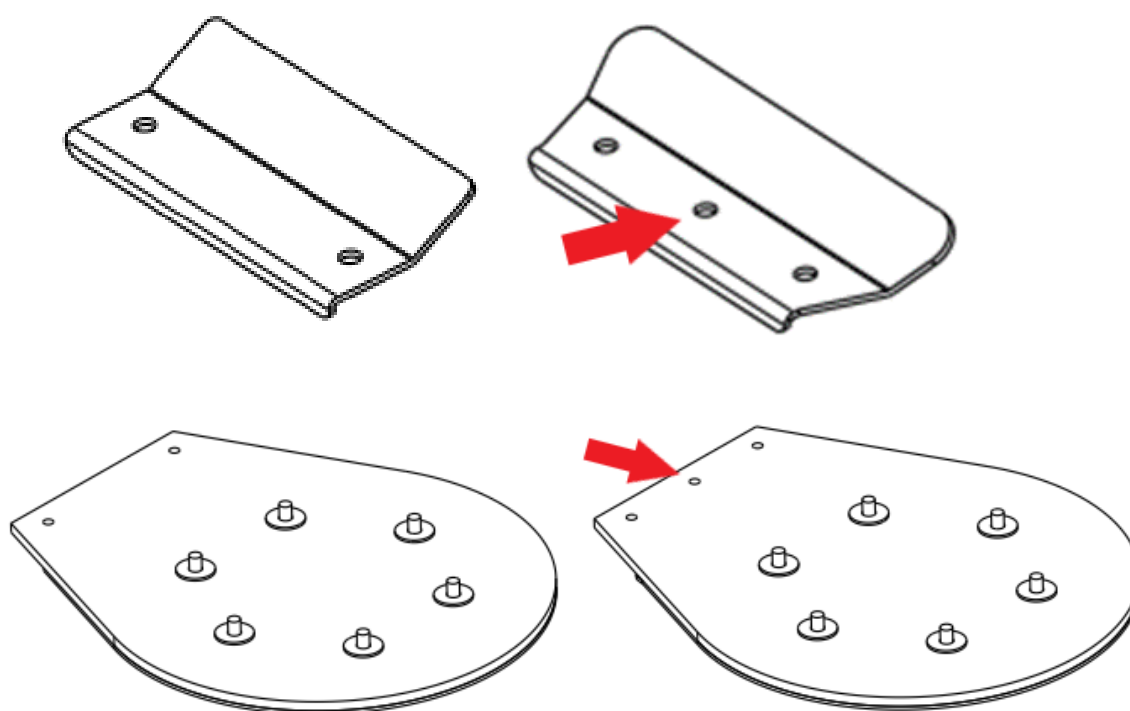
Be aware that the flap should not be bent downwards to open it more after attaching the Dust Extractor, as this will create additional stress leading to pre-mature wear of the Flap.

1. Disassemble and remove necessary parts to access Flap on Dust Extractor, and also parts to be replaced.
2. No pre-drilling needed on rubber part of Flap assembly to accommodate third fastener. Using the new metal plate as a guide, fasten the two outer self-drilling screws in the same place as previous two holes where located.
3. Fasten the third (new) self-drilling fastener in the middle using metal plate as guide.
