## SB, Grid Plug Issue, W70P, 2021-08

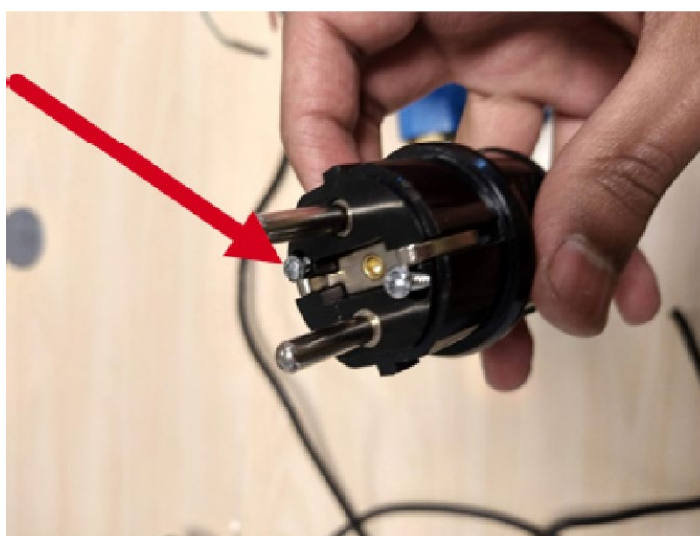
Incorrectly mounted plug, wires have been found to be not completely inserted and the cable is incorrectly placed in the strain relief.

1. Open the power plug and remove it from the cable.
