# SB, Supply cable damage, PP70, 2022-12

PP70 – All units

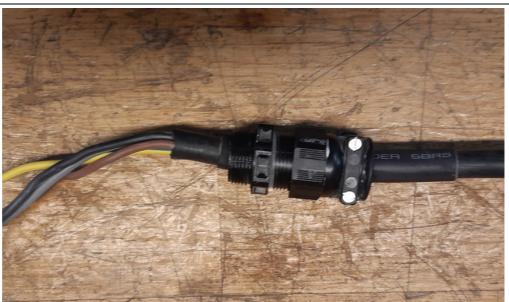
Note! Do not over tighten these screws or the cable will be damaged.

4 Install cable and shrinking tube with cable gland.
Tighten screws to 0,3Nm, **not more!**
