SB, Bearing breaks, DM400, 2022-05

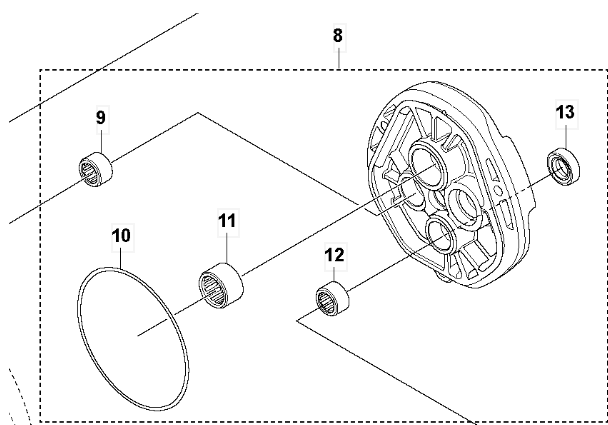
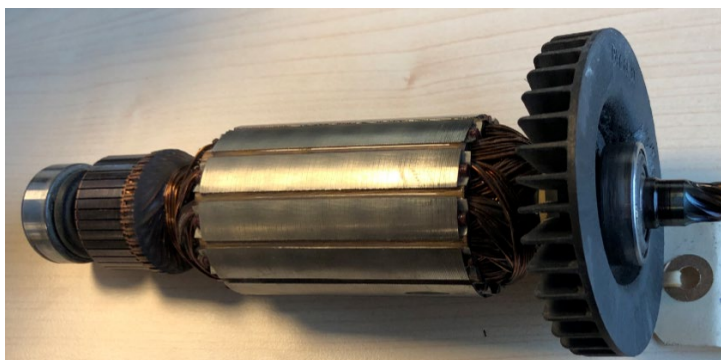
Field reports have shown that some bearings on the rotor break too easily. The heat generated from the broken bearing has caused damage to the rotor. The machining of the bearing seats has been changed to improve the situation.

If the front bearing of the rotor is broken, please change Rotor and Intermediate flange, see part numbers in table below.
