SB, Front bearing, K770 DRYCUT/VAC, 2023-04

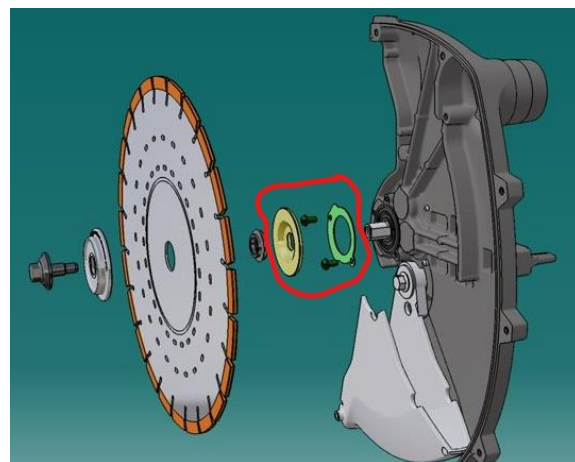
Figure 1:

Field reports have shown that the front bearings in the blade guard can move sideways towards the blade. This has been corrected by installing a plate which prevents the bearing from moving (circled in red in figure 1). The plate is installed with two screws in the blade guard. Blade guards on products produced after serial number 20224100001 have the two threaded holes (circled in red in figure 2).

On products with serial number after 20224100001, the SECURING PLATE (536863701), SCREW (578473502) and FLANGE WASHER (590370602) can be installed.
