SB, Front sealing pops out, DM400, DM430, 2021-03

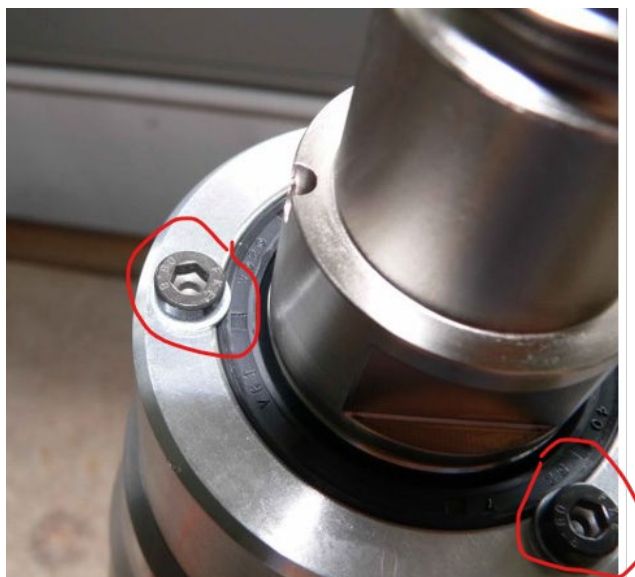
Quality field reports have shown that on rare occasions, the front sealing on the DM400 and DM430 can be pushed out by water pressure. To remedy this, a washer has been introduced for the three screws on the front water jacket to keep the seal in place.

Figure 1: Add three washers.

If sealing pops out of position, add a washer for each of the three screws (figure 1) to keep it in place.
