## SB, Hydraulic motor studs snap off, CRT 60, 2024-03

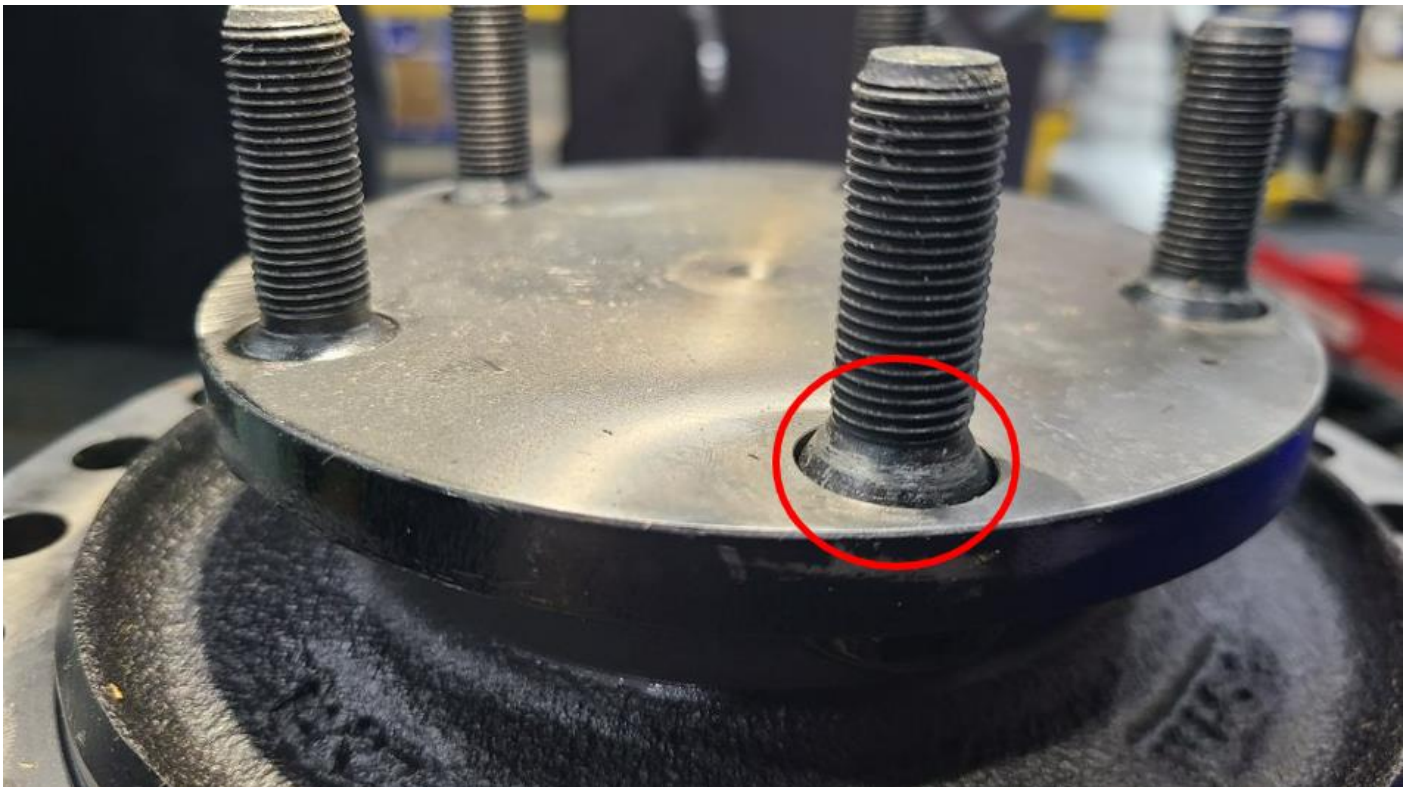
Due to a new type of studs with larger chamfers used by the supplier on the CRT 60 hydraulic motor, a gap between the motor flange and the stub shaft can occur (figure 1), causing the studs to snap off.

Fig. 1: New type of motor flange stud with increased chamfer.

A new revision of stub shaft 599062901 with chamfered holes is introduced.

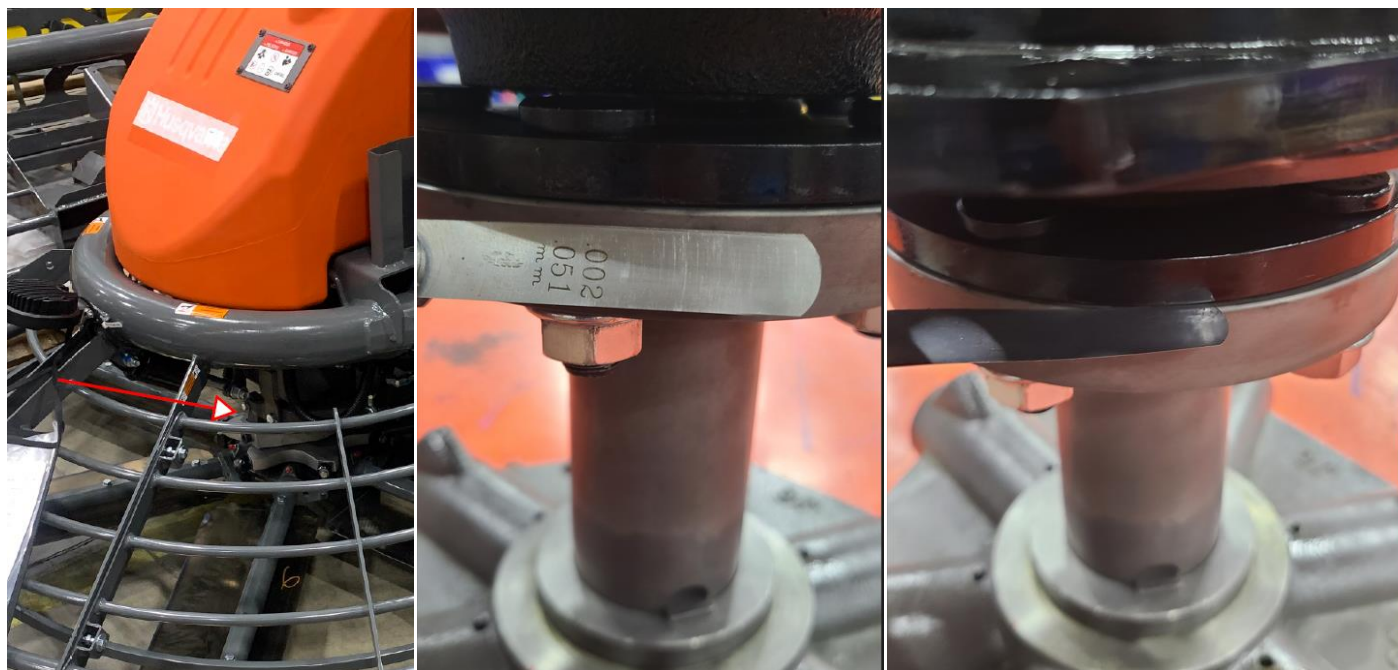
Check if there is a gap between the hydraulic motor flange and the stub shaft on both sides of the machine. Try to insert the thinnest feeler gauge from the set between the hydraulic motor flange and the stub shaft (figures 2 – 4).

Fig. 2 - 4: Check if there is a gap between the hydraulic motor flange and the stub shaft.

Try at several points along the diameter of the flange.

The gauge should not enter between the parts.

If the gauge is possible to insert, then change or modify the shaft 599062901.

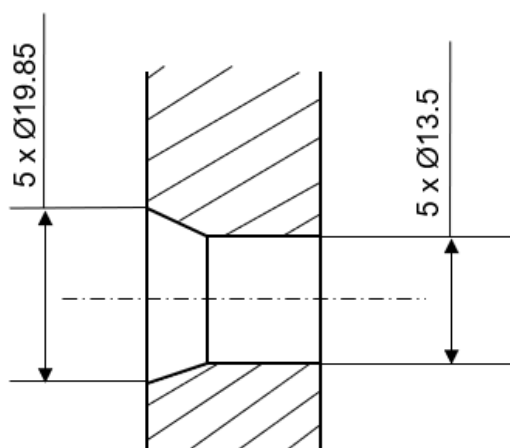
Fig. 5: Use a 60° countersink drill bit to make diameter equal or slightly bigger than 19.85 mm.

Modification should be done by using 60° countersink drill bit until each hole diameter is equal or slightly bigger than 19.85 mm, see figure 5.

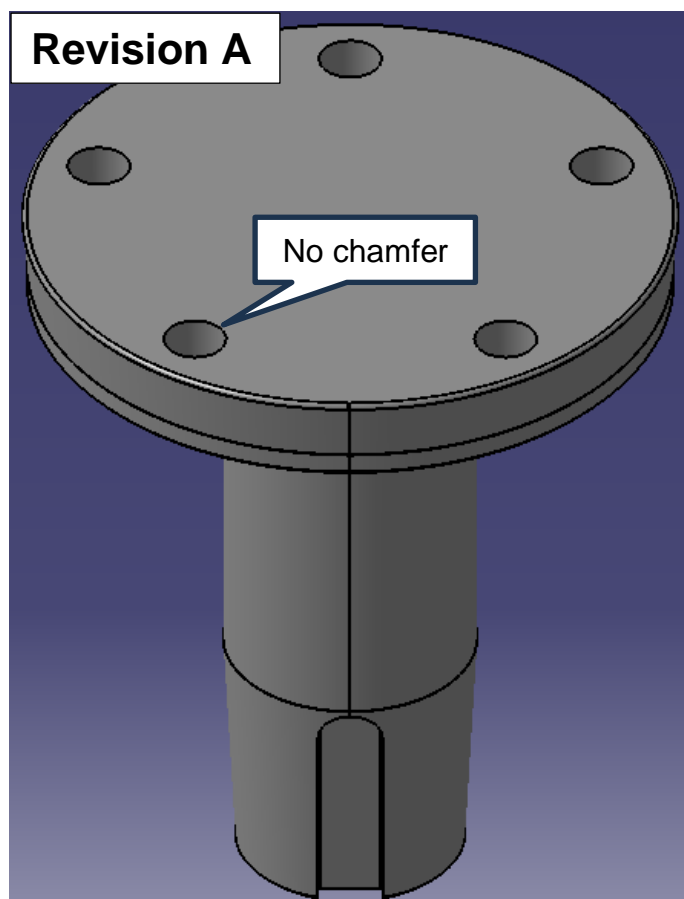
Fig. 6: Revision A, old revision with straight holes.

Check the local stock, all parts of revision A (figure 6) should be scrapped or modified.

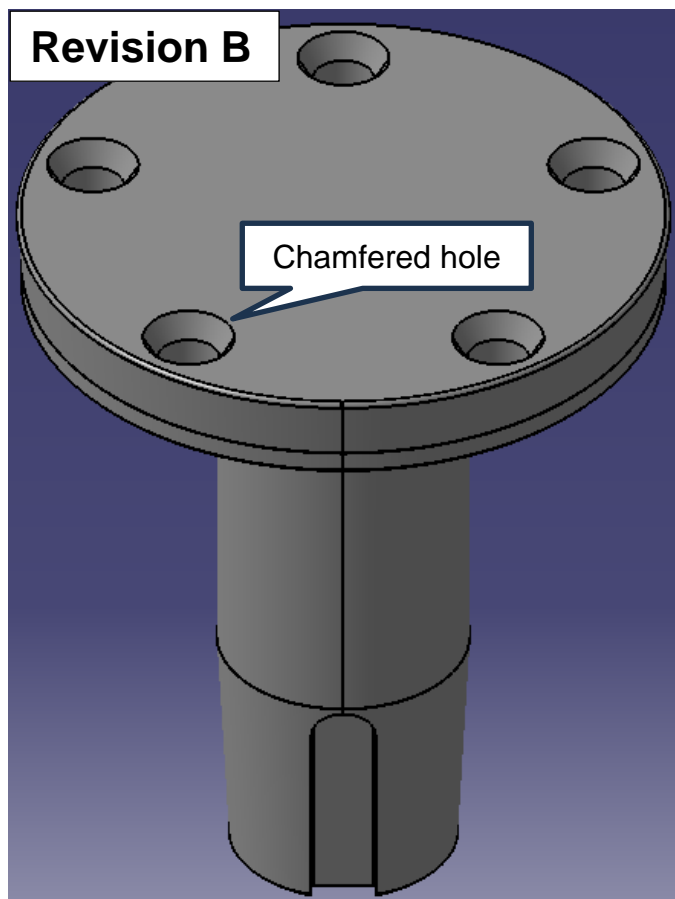
Fig. 7: Revision B, new revision with chamfered holes.
