SB, Hose adapter broken, WT15i, 2023-07

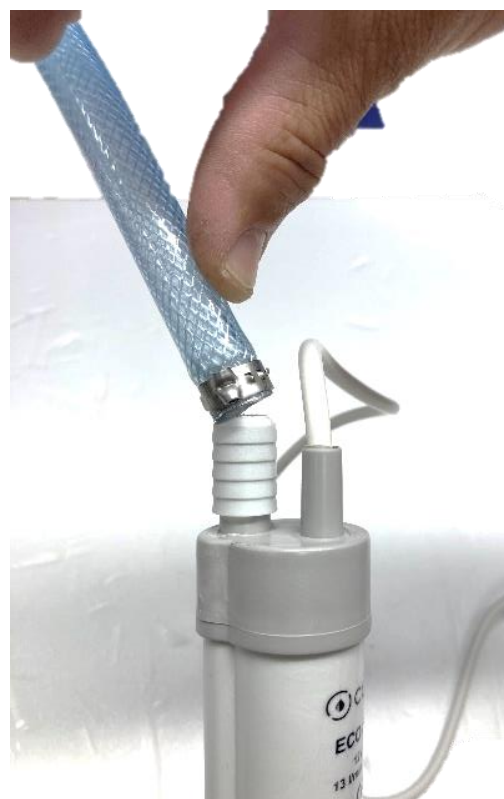
There is a batch of WT15i with broken hose adapters which will not work properly until the hose is re-attached.

Check if adapter is broken on affected WT15i by visual inspection, then gently press against the side of the adapter (figure 1) to determine whether it is secure or loose.

Fig. 1: Press against the side of the adapter.

If a loose adapter is found, then replace the pump with spare part:

Pump (577065202) and clamp a new hose clamp (591123101) to secure it.

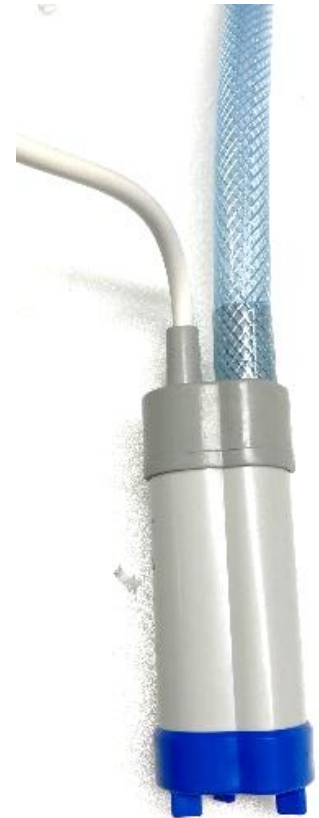
Fig. 2: Workaround carried out.

1. Remove the broken adapter. Either by first softening the adapter with a heat gun and prying it off with plyers or use a knife to split the adapter and rip off the rest.
2. Clean the surface where the hose should sit.
3. Apply glue (Loctite 406) to the pump all around where the hose should sit.
4. Mount the hose on the pump and let it rest for five minutes.
5. Do not use any hose clamp.

1. Replace the pump with spare part: Pump (577065201).
2. Clean the surface where the hose should sit.
3. Apply glue (Loctite 406) to the pump all around where the hose should sit.
4. Mount the hose on the pump and let it rest for five minutes.
5. Do not use any hose clamp.
