DMS 240 bearing support and thermal circuit breaker replacement.

*During quality control, two issues with DMS 240 have been found.
This service bulletin describes how to check, and how to solve them.*

DMS 240 Bearing support replacement

DMS 240 Thermal circuit breaker identification

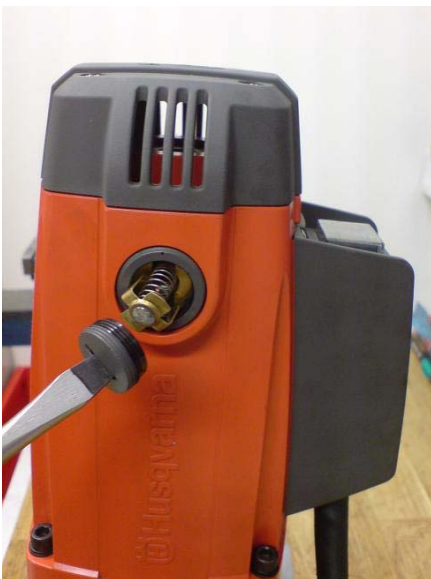
Picture 1. Removal of brushes

1. Remove the two screws with a large flat bladed screwdriver and remove brush from motor housing.
2. Remove the four Philips head screws securing the back cap and remove the cap

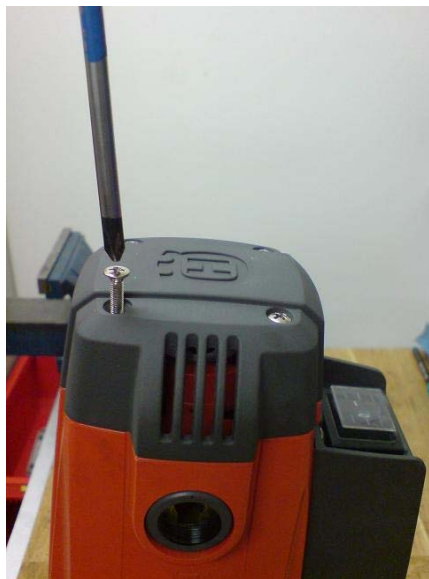
Picture 2. removing the back cap screws

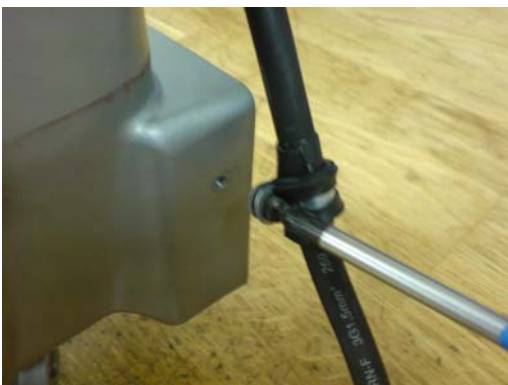
Picture 3 removal of the cable clamp

3. Remove the small Philips head securing the cable clamp.
4. Remove the four hex screws on the motor housing and remove the housing.

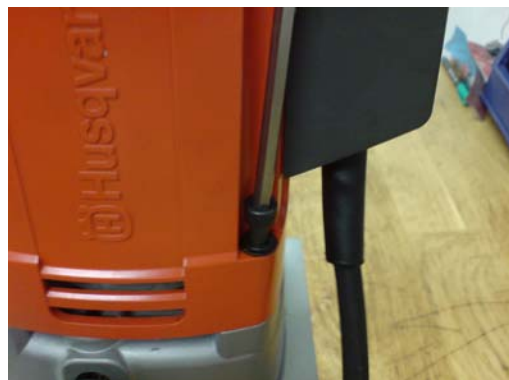
Picture 4 removal of the motor house screws

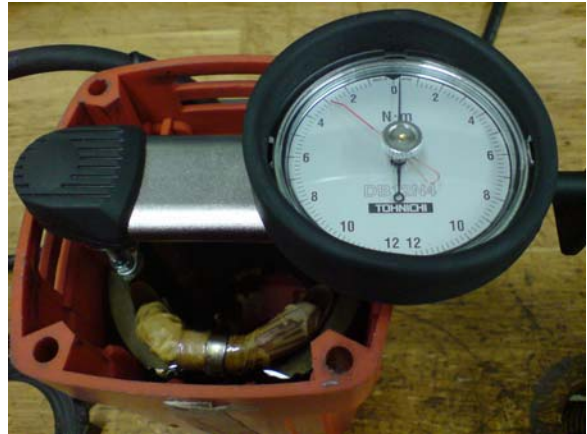
Picture 6 Tighten stator screws

5. Remove black plastic air leader from inside the motor housing.
6. Tighten the two stator screws to 3Nm using a torque wrench as seen in picture 6.

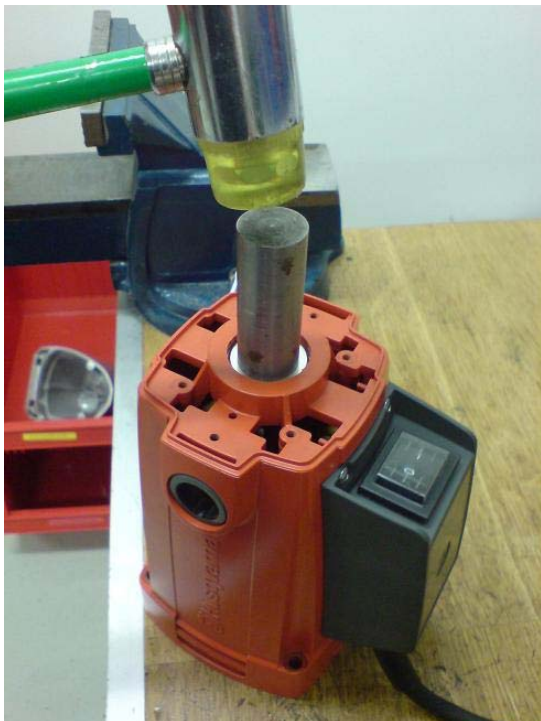
Picture 7 removal of the bearing support

7. Remove the bearing support from the motor housing
8. Assemble the new bearing support on the rotor bearing (heat the bearing support with a hot air gun to ease installation). After installation gently tap the rotor shaft with a rubber mallet to make sure that the rotor is seated correctly in the gearbox.

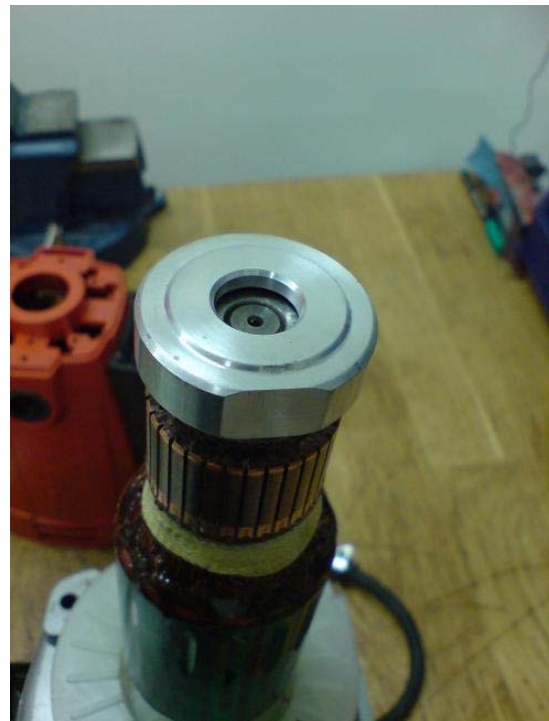
Picture 8. Assembling the bearing support

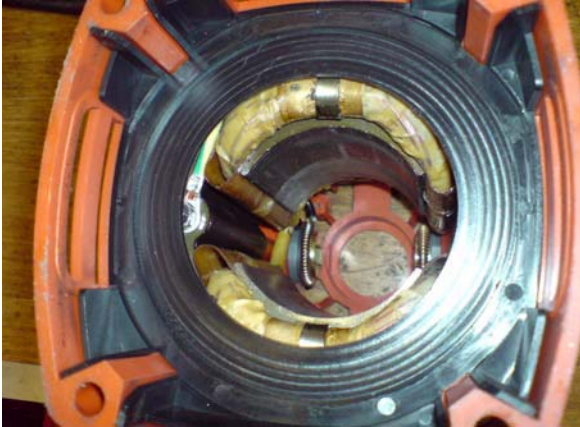
Picture 9. Install air leader in the housing as in picture

9. Reinstall the black plastic air leader in the motor housing as shown in picture 9.
10. Reposition the motor housing over the rotor. Make sure that the flat side on the bearing support is parallel to the flat surface of the motor housing as shown in picture 10. Push the housing forward until bearing support is in place.

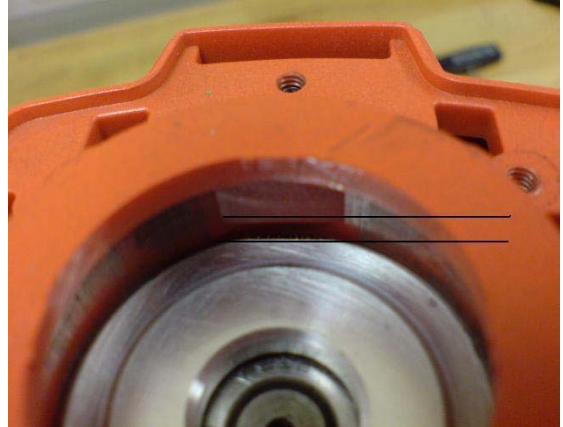
Picture 10. Planes should be parallel

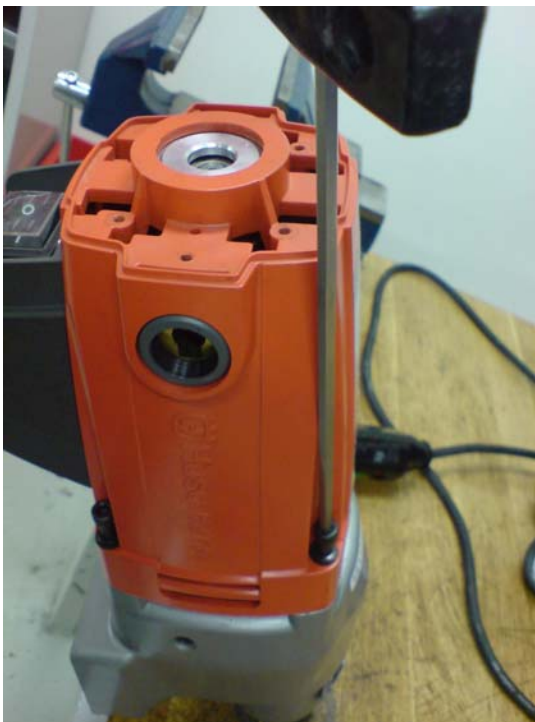
Picture 11. Tighten motor housing screws to 4Nm

11. Reinstall the four hex screws securing the motor housing and tighten to 4Nm
12. Reinstall the two brushes and screws.

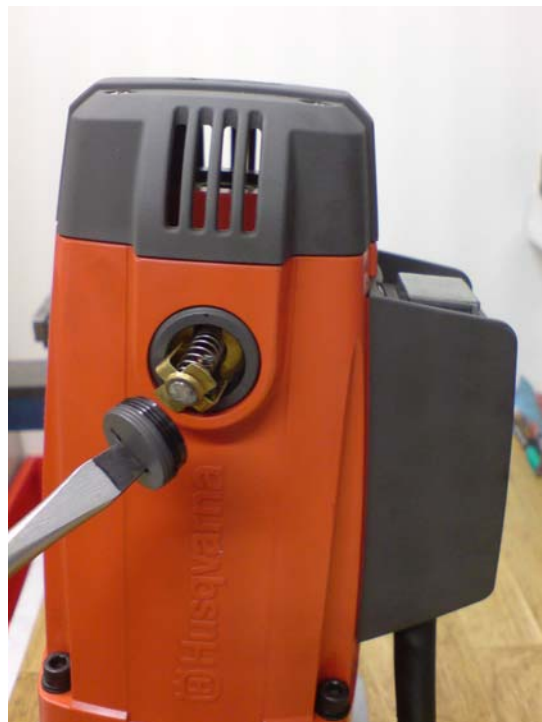
Picture 12. Reinstall brush and screw

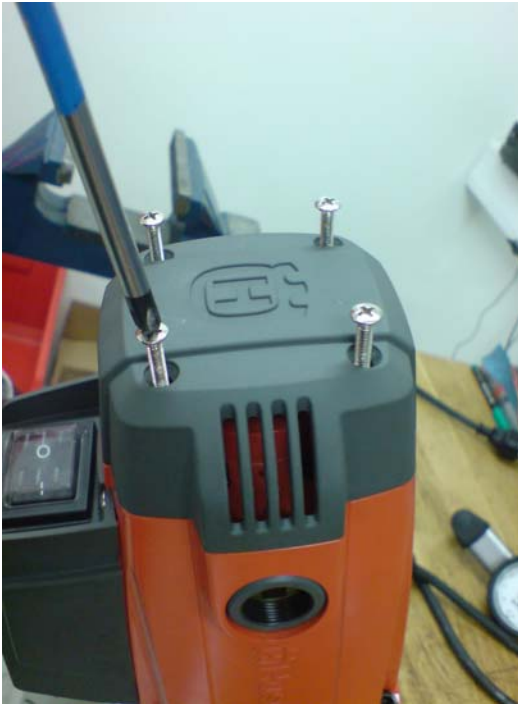
Picture 13. Reinstall back cap screws

13. Reinstall back cap and tighten the four Philips head screws.
14. Place one red sticker on gearbox

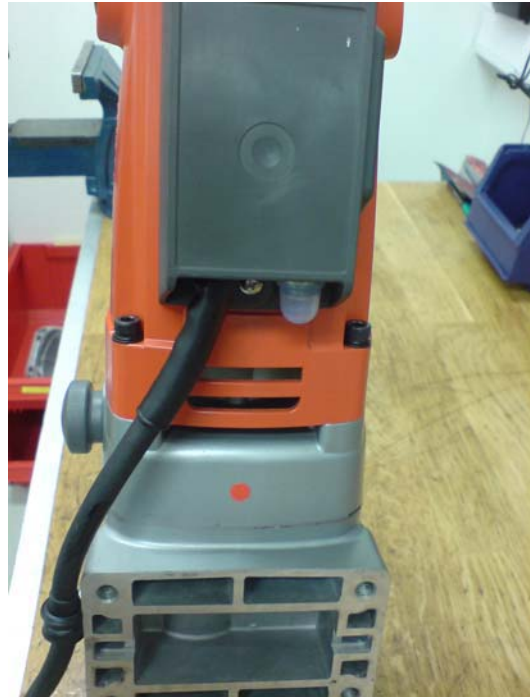
Picture 14. Sticker is placed on gearbox

As from serial number **1287**, this update is done in production.
During a limited period of time, all DMS 240 will be marked with a red sticker.
(See picture 14)
Also the DMS 240 package is marked with a similar red sticker.

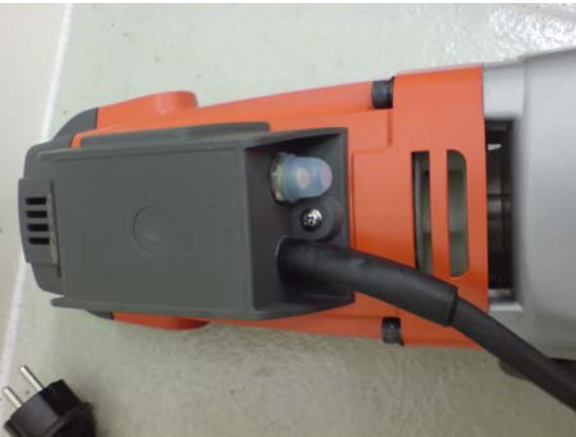
The new thermal circuit breaker for the 230V drill motor is identified by checking the color of the sealing boot. The new type shown in picture 1 has a blue silicone dust cover. The old type shown in picture 2 has a white silicone dust cover.

Picture 1. New type with blue silicone dust cover (522 81 11-02)

If a machine has the old type of breaker, this should be removed and the new type should be installed. Be careful not to damage any of the electrical cables during the installation.

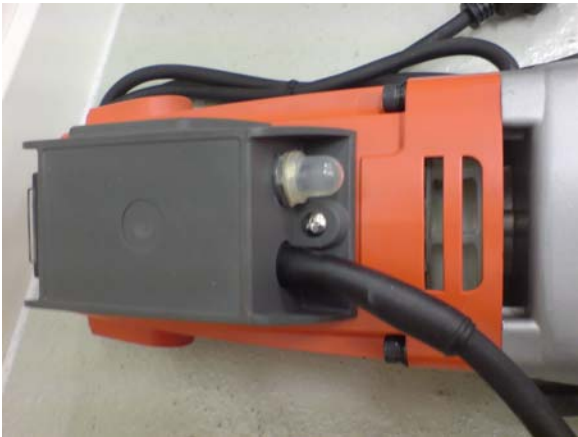
Picture 2. Old type with white silicone dust cover (522 81 11-01)

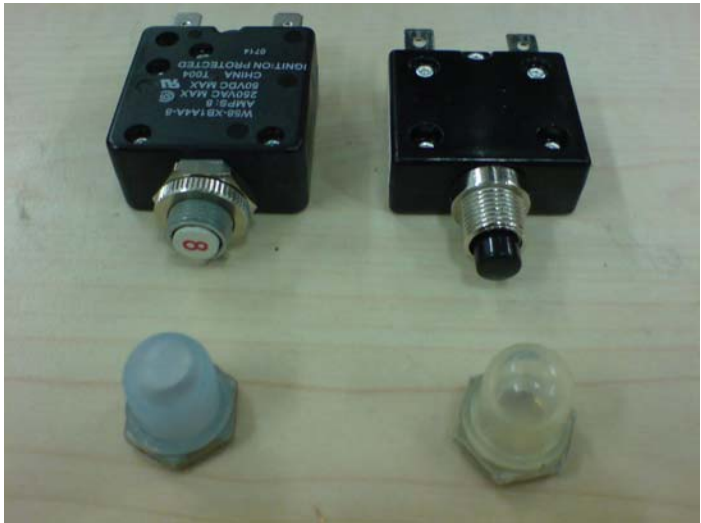
The new breaker shown to the left in picture 3 has a white reset button and blue silicone dust cover.

The old breaker shown to the right in picture 3 has a black reset button and a white silicone dust cover.

The threads on the breakers are also different so only the correct dust cover should fit correctly.

Picture 3. The new circuit breaker is shown to the left and old type to the right
