SB, Lower Belt Guard, LG164, 2022-06

SYMPTOM/DESCRIPTION

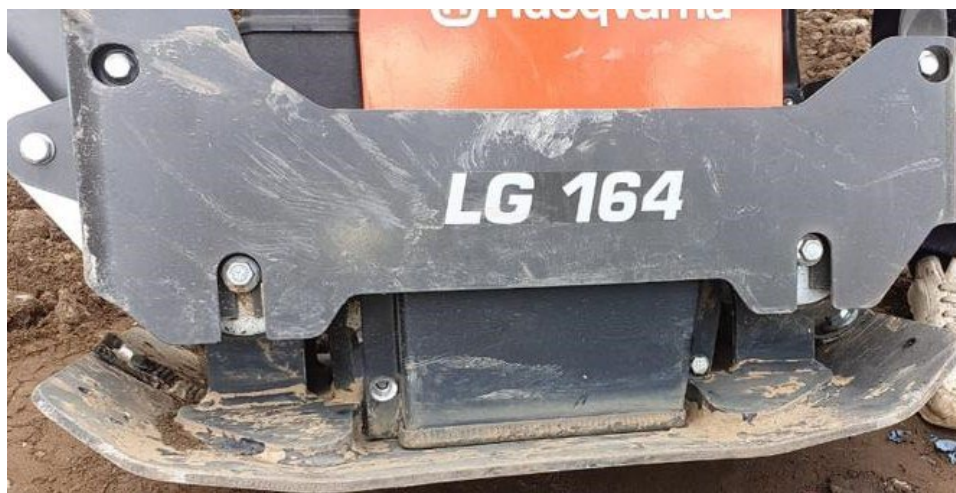
Figure 1:

For some unknown reason, all the Lower Belt Guards of LG160 (phased out), LG164, LG200 (phased out), LG204, LG300 have screw holes of 12 mm and LG400 has 11 mm holes. The obvious conclusion was that these too big holes allow the Lower Belt Guard to move during the vibration of the plate, widening the holes even more and in the worst case even breaking the affixing screws.

As these holes were of such size from day one, we suspected that there must be something else going on here. Investigations led to the conclusion that when the painting of the eccentric housing and the lower belt guard is too thick, the paint cracks around the holes when the screws have been tightened. Due to the bigger holes in the Belt Guards, the screw heads are squeezing over less surface, increasing the contact pressure over a smaller area. If the paint layer is thicker, it would crack under the tightening force. As a result, the screws may become slightly loose. This is what allows the Belt Guard to move when the machine vibrates, to shake up and down and widen these 12 mm holes even more. In a worst case scenario, this would lead to deformation of the holes in the Guard and even to some of the affixing screws breaking.

As a first measure, the size of the screw holes of the Lower Belt Guards was changed from 12 to 9 mm. This measure should bring down the contact pressure between the screw heads and the holes in the Lower Belt Guard, thus preventing the cracking of the paint even if it is a bit thicker. As a result, the screws shouldn't come loose.
