## SB, Special Sealing, K3600, K2500, 2011-01

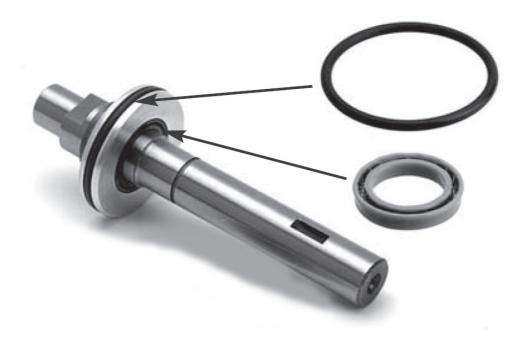
When running the hydraulic products on to high pressure, and/or flow the shaft sealing can start to leak.

When problems like this occur the original sealing can be replaced by a special sealing.

When assembling the sealing it has to pass some sharp corners on the shaft therefore a assembly tool is attached with the sealing together with an instruction.

Please follow the instructions!
