SB, Shot blasters skid seal modification, 2024-04

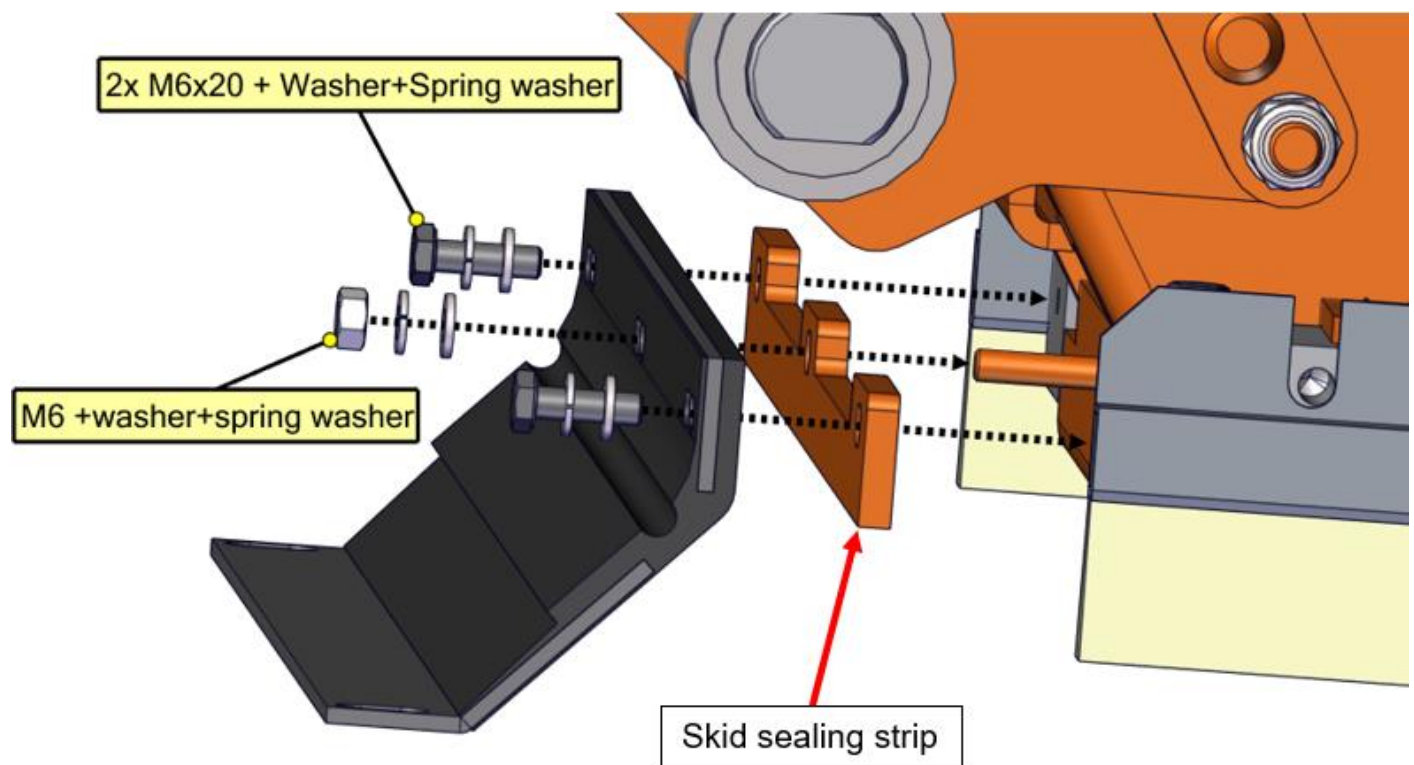
Appendix A

Installing the skid sealing strip.

The strip ensures that the skid seals are sealed evenly around the housing.

Installing the strip behind the skid seal will solve the issues.
