# SB, New robust water nipple, K7000 family, 2023-05

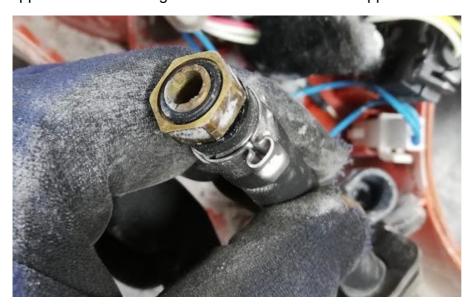
Field reports have shown that the water nipple for the motor on PRIME family can break. The nipple has been changed to a more robust water nipple with thicker walls.

Figure 1: Broken water nipple.

Part Name	Old Part No.	New Part No.
Water Nipple	501282902	501282903
