# SB, Supply cable damage, PP70, 2022-12

PP70 – All units

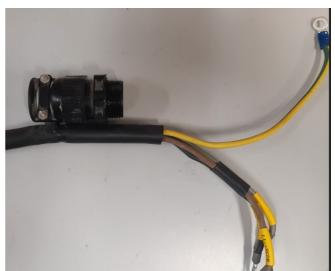
Field reports have shown that the supply cable for PP70 can be damaged by the cable gland.

- Symptoms of this issue are:
  - Yellow warning light on PP70 User interface
  - Blown fuses
  - Working on one phase or three phase.

Check if cable is damaged visually and by measuring the cable ends for continuity.

If cable is damaged, shorten the cable or replace it and install protective sleeve as described in *Appendix A* below.

If cable is undamaged, please install cable sleeve for future protection.
