## SB, Hose comes lose, WT15, 2021-02

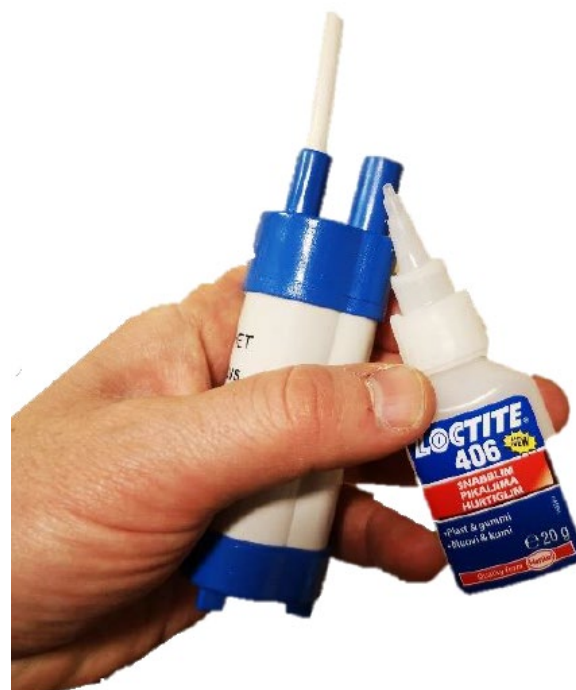
Field reports have shown that the hose that connects to the pump in the WT15 can come loose. To remedy this we have glued the hose to the pump.

1. Clean the surface where the hose should sit.  
Apply glue (Loctite 406) to the pump all around where the hose should sit.
