## SB, Depth adjustment bearing assembly, FS 400 LV, 2013-01

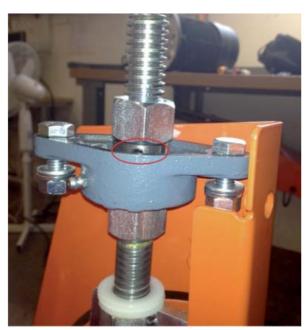
Picture 2 show how it will look like when the inner part of the bearing is rotated and the shaft is mounted.

Picture 2 The SKF bearing correct mounted on the machine.
