SB, OPTIMA Batteries testing, 2021-03

SYMPTOM/DESCRIPTION

Some of our clients experience problems with the OPTIMA batteries we include in some of our Light Compaction machines.

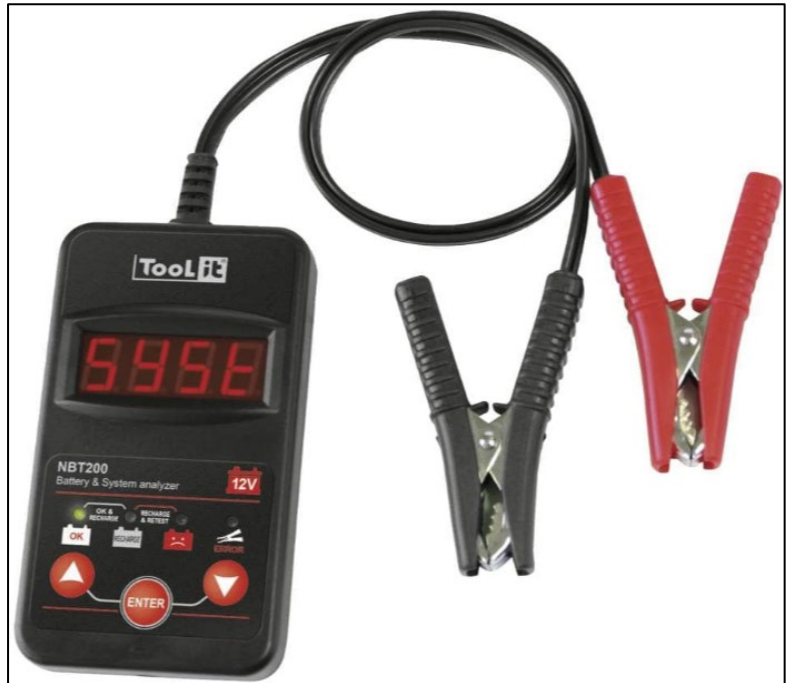
Figure 1: NBT 200 Battery & System Analyzer.

What we in the assembly factory do is basically a check of the voltage and current of the OPTIMA batteries with a device called NBT 200 Battery & System Analyzer (figure 1). The Operating Manual of NBT 200 can be found on the world wide web.

The Operating Manual of NBT 200 tester describes the steps and actions to be performed in order to find the voltage and current the battery supply at the moment. This device simplifies the answer to the user in a set of three light signals, green, yellow and red. These signals might be present in the following combinations:

- A green light on only, indicates that the battery is in a perfect condition
- Both green and yellow lights on, indicates that the battery is in good condition, but charging is recommended
- Both yellow and red lights on, indicates that the battery is low on charge and must be charged and tested again
- A red light on only, indicates that the battery is at the end of its life and should be replaced.
